RE: Medians at Liberty Park - Reduced Safety - Increased Risk

Wednesday, August 6, 2025

Example 2: Median on Alameda between Prospect and Liberty Park

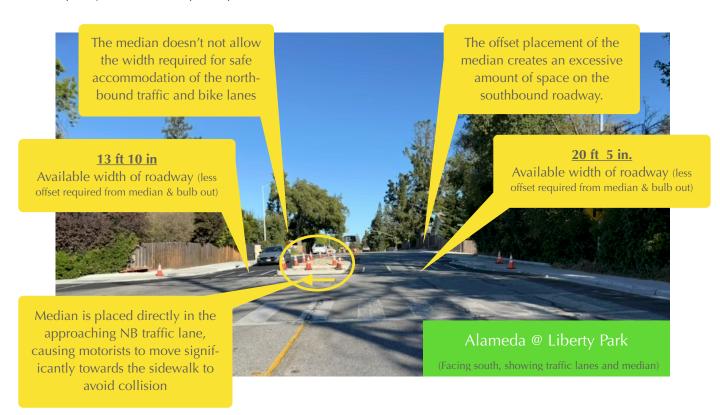
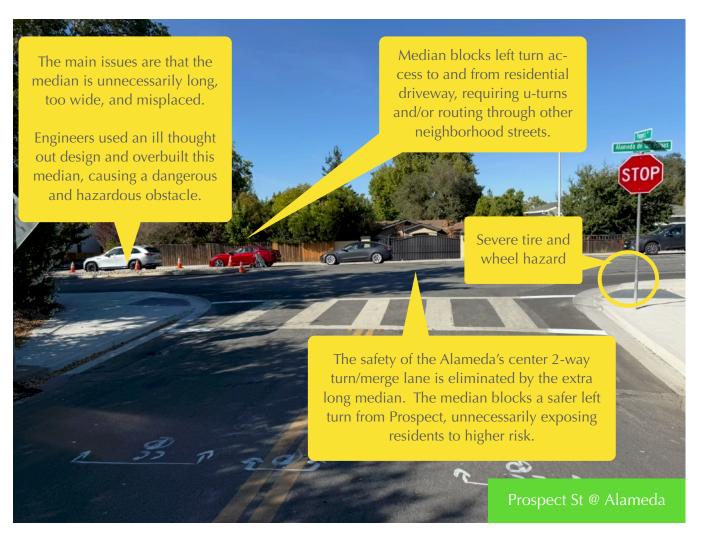
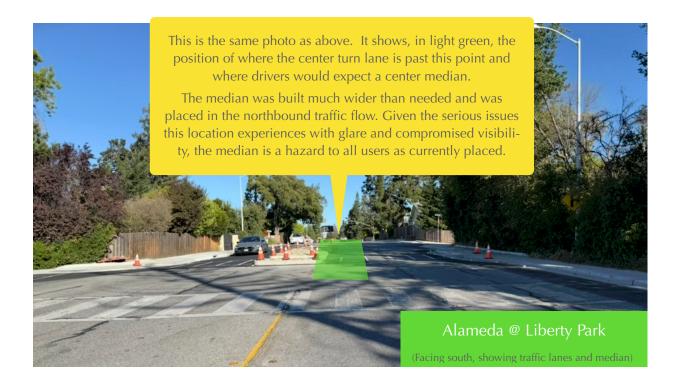
- In the northbound direction, the median does not provide sufficient roadway width to safely accommodate one northbound traffic lane, a 5' bike lane, and the required offset (also known as shy distance) for the median and bulb outs. It appears that the median placement may not provide the width necessary to comply with the 3' cycling law.
- The median is excessively long. There seems no valid safety reason for such an excessively long median; in fact, it creates safety risks for residents:
 - For instance, residents of Prospect St. are prohibited from using Alameda's center two-way turn lane and must wait for traffic on Alameda to clear in both directions before making a left

- While the northbound lane is overly narrow and lacks roadway width, the opposite is true for the southbound lane, which gives the impression of a super wide-open roadway capable of two traffic lanes. Our safety task force collaborated with DPW from 2017-2020 to ensure that traffic lanes would be 10' wide, primarily to provide motorists with a perspective of a narrower road and a more residential atmosphere, thereby achieving calmer and slower traffic. However, with such a wide roadway on the southbound side, motorists may not perceive a different road perspective—a super wide roadway.

- This median is 11' wide, wider than the 10' wide center 2-way turn lane that was agreed to. Due to required offsets to protect motorists from the high median curbs, the width of this median could/should be at least 3 feet narrower.

- The median's design and location, situated on the crest of a hill, ignores the visibility challenges that
 exist here on Alameda. Glare from the sun and headlights significantly impair a motorist's ability to see
 the median. Furthermore, its placement is unexpected, as most drivers do not anticipate a median to
 abruptly obstruct a substantial portion of their normal travel lane..

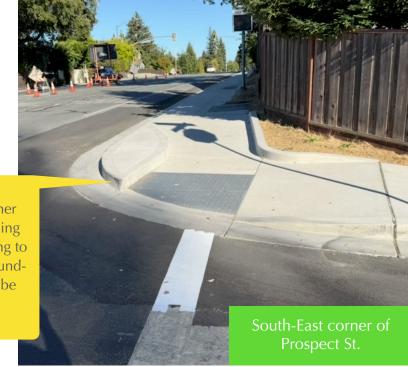
This sharp pointed curb corner has a high likelihood of causing tire and wheel damage, leading to tire failure. It seems that a rounded or ramped corner would be safer and less damaging.
